## THE PRESERVATION AND REINCARNATION OF SID-LIN MONASTERY

Li HAO

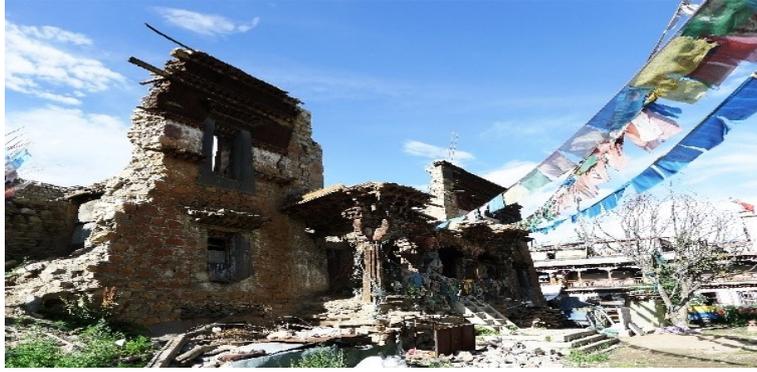
Fig 2. Front of present Sid-Lin Main Temple, photoed by author, 2011.

Some say that Sid-Lin Monastery was completely ruined during this "Reting Event". After the death of Reting living Buddha, Dazha gave an order to dress up the body and transfer the body to Sid-Lin Monastery. Reting living Buddha was libeled against, which triggered the anger of the mass. Then Sid-Lin Monastery was set on fire. That is how Sid-Lin Monastery was burnt to ruins". However, this version of explanation is hardly convincing. Sid-Lin Monastery was originally the residence of Reting living Buddha. The question is: why the mass public, who admired him, instead of taking actions against those who persecuted the living Buddha, invaded the residence of living Buddha? Others believe that Sid-Lin Monastery was not ruined during this event, but was only closed. The monastery was ruined in 1959. No matter which version is correct, there is one thing for sure, i.e., the attacks by wind and rain in the following fifty years are the main reasons for the current situation of Sid-Lin Monastery (fig 2).

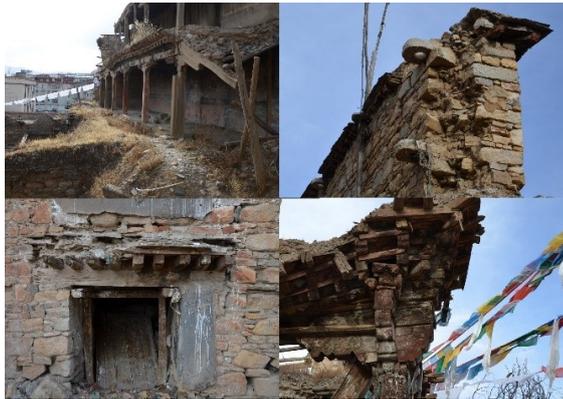
Fig 3 (left). Damages of Sid-Lin Main Temple, photoed by author, 2014.

The monks' residences surrounding the main monastery were repaired twice and preserved well. They are now the main site of aggregation for the residents. The remains of the main monastery are currently in a poor state, from which we can hardly recognize the original structure of the architecture. The large building located in the northernmost section of central axis of the entire courtyard can be divided into two parts, front and back. The scripture hall in the front was initially of a two-tier structure, which is nowhere to be found currently. What is only left is the fragmented stone-made outer walls on three sides. At the entrance, the wooden structure is already rotten, with a large part fallen off. The small components such as the cornices of the window are badly mutilated. At the back was initially the storage space, the residence and three Buddha Halls. The top of the Buddha Hall no longer exists, with only the partition wall left. The private balcony of Reting living Buddha only has the large part of rooftop and the beams and pillars, all of which are deformed to some extent. The structure in the east is on the brink of collapse (fig 3).

There is an one-meter-thick outer wall left in the main monastery. It is not completely made of bricks, but has stones and sand fillings in the middle, which are

exposed after the surface brickwork has shed. Rain and wind will deprive the load-bearing capacity of the fillings, thus increasing the risk of collapse. Similar situation is also found with the wooden components. Timber will be deformed under the impact of wind and sunshine. The change of the load-bearing structure will spontaneously collapse even in the absence of human factors. We have collected some photos of the remains of Sid-Lin Monastery in different periods since 1980s. The above-mentioned situation mostly occurs to the outer wall in the east, the top of the wall in the north and the entrance of the main monastery. However, natural erosion is very likely to deteriorate (fig 4).

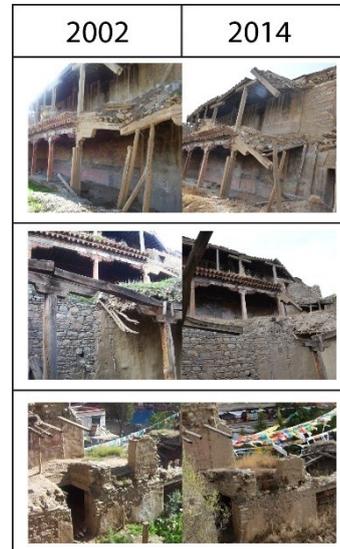
Fig 4 (right). Deterioration in past 12 years, pics 2002 were photoed by Mao Zhonghua, pics 2014 were photoed by author, organized by author.

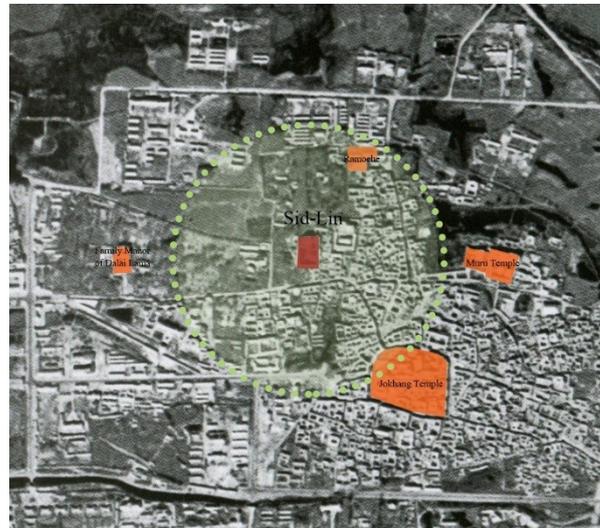
Fig 5. The context of Sid-Lin, based on satellite imagery, 1965.

interesting about the relative positions of Sid-Lin Monastery (fig 5). If a circle, with the radius of 590 meters, is drawn with Sid-Lin Monastery as the center, then the main buildings in the old urban district, such as Jokhang Temple, Ramoche Temple and Muru Temple are found along the circumference. That is to say, the working staff of Sid-Lin Monastery can reach these important sites after 6-8 minutes of walk. If the working staff of these institutes hope to visit Reting living Buddha, they can also arrive Sid-Lin Monastery within a very short time. Such a short distance not only shortens the time to arrive at different places from Sid-Lin Monastery, but also provides enough room for the formation of auxiliary plots under the influence of Sid-Lin Monastery. In its prime days, there was a relatively large area of private garden of Reting living Buddha surrounding Sid-Lin Monastery, except residences and spared land.

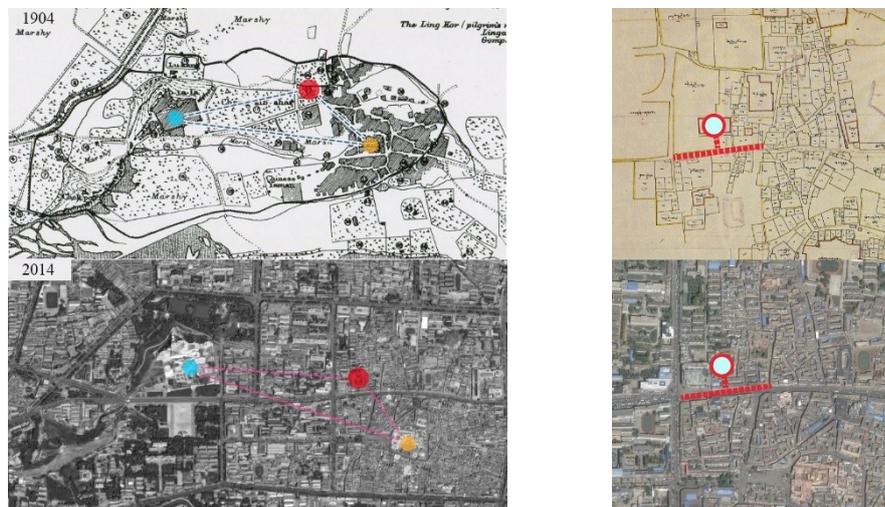
Fig 6 (left). Comparison of the relative position of Sid-Lin, based on map and satellite imagery.

Fig 7 (right). Unchanged relationship between Sid-Lin and Beijing Road, based on map and satellite imagery

Ryder and Cowie drew the first plain view of urban district of Lhasa in modern times in 1904. This plain view is compared with the map of the present day (fig 6). It can be observed that the relative position of Sid-Lin Monastery in the urban district has not changed. Here we mean the historical continuity of urban texture constituted of the surrounding traffic routes. That is, the urban layout with blocks as the unit remains basically unchanged. However, some changes have been made to allow the vehicles to pass through. The changes are divided into two types: first, the original roads are classified by road surface and then subject to hardening treatment; second, the original roads are extended, so that they can form the transportation network.

accurate speculation. What supports this speculation is the map of the central district of Lhasa drawn by Peter Aufschnaiter in 1948. On this map, the real estate marked out on the two sides of East Beijing Road basically conform to the urban texture of the current day. Especially, the position of Sid-Lin Monastery relative to the road has not changed. Its wall in the south is still 40 meters apart from the north edge of East Beijing Road (fig 7).

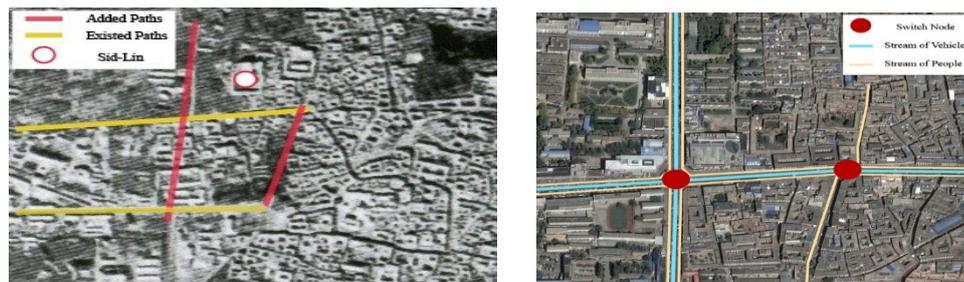
Fig 8 (left). Reorganization of roads near Sid-Lin, based on satellite imagery, 1965.

Fig 9 (right). Analysis of traffic streams, based on satellite imagery, 2014.

For the second type of adjustment of urban traffic, we also take the two roads near Sid-Lin Monastery as an example. They are the middle section of Duosenge Road in the southwest and Danjielin Road in the southeast. The arrangement of the two roads directly influences the layout of west section of old urban district. Their north sides are connected with East Beijing Road; the south sides are connected with the east part of Yutuo Road in front of Jokhang Temple square (actually named as Bharkor Street, but to make a distinction from Bharkor Region of Jokhang Temple, referred to as east part of Yutuo Road). Thus, a new urban block is enclosed. The north side of Duosenge Road is a narrow dirt road, which is probably the west boundary of the garden to which Sid-Lin Monastery belongs. The south section of Duosenge Road is its extension. Early satellite images show that during the repair process, at least five large-scale courtyards were demolished. But since this region is situated on the brink, we cannot decide whether these buildings were once part of the old urban district of earlier times. The urban open space on the two sides of north section of Duosenge Road is occupied by various modern architectures. A street rich with commercial atmosphere is formed. The situation of Danjielin Road is similar to that of Duosenge Road. But the difference is that Danjielin Road is built on the original swamp. During the construction, the original buildings were not demolished in large quantity. Danjielin Road of the present day is a well-known place for purchasing souvenirs. The buildings on the two sides of the road are still being renovated. (fig 8)

but they will soon leave within a few minutes (fig 9).

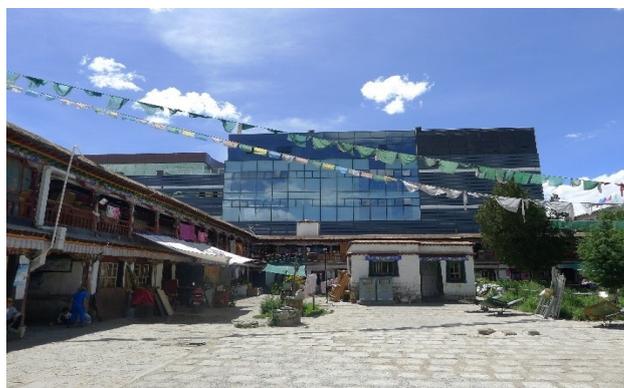
Fig 10 (left). Present situation of west exterior elevation of Sid-Lin, photoed by Lobsang Draga.

Fig 11 (right). Discordant modern elevation against Sid-Lin Courtyard, photoed by author, 2014.

The west outer wall of Sid-Lin Monastery is only 6 m away from the adjacent buildings, and the length of being parallel is over 30 m. Thus, a long and narrow space is created. The south of this space is used as the channel for logistics, where the vehicles delivering cargos will stop. This is also the place where the domestic garbage is carried away. The neighborhood committee in the north encloses a site for storing sundries together with the wall of Sid-Lin Monastery. Except for the working staff of the shops and the neighborhood committee, there are few other people accessing this place, let alone doing routine maintenance of the outer wall of Sid-Lin Monastery (fig 10). The outer wall, standing nearly 24 meters, nearly blocks the sunshine at noon. Although this situation is not serious at the moment, the dimness of the room is partially due to the existence of the Tibetan architecture itself, but can be remedied by artificial light source. Under the strong sunshine in plateau area, local residents may set up temporary shacks to block the parching sunlight. But the residents have complained, especially those living in the west, that the shadow of the commercial complex will cover the large part of the courtyard at about 5 in the after in winter when the solar zenith angle is low. It is about 2 hours earlier than the originally 7 in the evening. What also irritates the local residents is the vision inside and outside the courtyard. Before the commercial complex was built, one can see the Potala Palace from Sid-Lin Monastery in the west direction. From the perspective of urban landscape, the upper part of the main monastery can be visualized at the intersection between East Beijing Road and Duosenge Road. But at the present day, it is largely obstructed (fig 11).

The buildings inside and outside the blocks are apparently divergent stylistically. But the influence on the overall landscape of the old urban district is limited. One reason is that the architecture is located on the edge of old urban district. The continuity of traditional Tibetan landscape along East Beijing Road is partially interrupted before that. This region has basically completed the transition to modern commercial landscape. In addition, the streets of the old urban district are narrow. Near the east outer wall of Sid-Lin Monastery, one can hardly feel any incongruence of buildings in terms of visual effect. However, things get quite serious if one observes within the range of Sid-Lin Monastery. The west and south outer facades facing the urban roads are the combination of modern and traditional style. However, the east facade is simply the modern style, with large-area glass curtain wall decorated by deep gray strips, which poses a stark contrast to the traditional

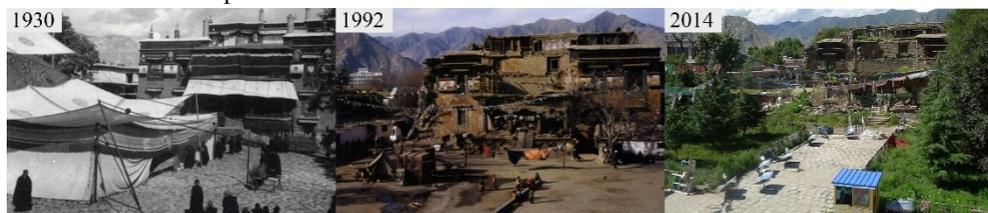
Fig 12. Sid-Lin Courtyard in 1930s,1992,2014. pics 1930s,1992 were quoted from *The temples of Lhasa Tibetan Buddhist Architecture*, pics 2014 was photoed by author.

Sid-Lin Monastery was once a spiritual place for Buddhists' practice. But now it becomes a mundane community for residents (fig 12). As mentioned before, the main monastery of Sid-Lin Monastery had been a residence of Rezhen living Buddha for a long time. Its large-scale monks' apartments in the surroundings were established under such circumstances. Such unit is called Dratsang in the organizational system of Monasteries of Tibetan Buddhism. A Dratsang is similar to a school in universities nowadays. It can be an independent unit with its complete organization and its own property as well as working capital. Those who live in a Dratsang are almost all monks in Buddhist practice. Though they are different at Buddhist accomplishments, job title and social status, they all practice religious activities of the same nature in this yard. In a particular historical period, these activities endowed Sid-Lin Monastery with a strong spiritual attribute which was beyond physical space. This spiritual attribute will not disappear along with its material carrier, but will fade with time or be covered by new attributes. It is none other than the residents who bring new attributes.

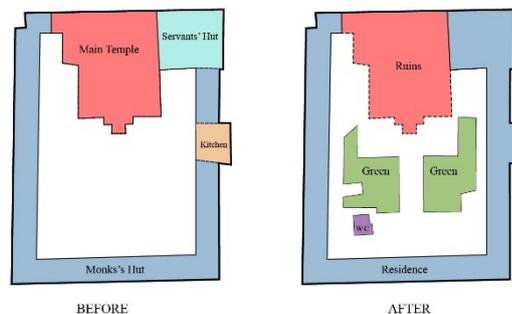
Fig 13. New organization of Sid-Lin courtyard reduces the accessible public area.

In 2003, the government organized another large-scale renovation on Sid-Lin Monastery. This renovation still focused on the improvement of its living condition so that no repair was done on the ruins of the main monastery. However, this renovation aimed not only at renovating monks' apartments which were today's residential houses but also at reconstructing the yard's layout. Shanties built in the yard by residents without permission were torn down. To fulfill residents' request of increasing the actual useable area of their houses, the original porticoes of the first floor were joined by walls but with the building elevation of monks' apartment basically reserved. In terms of the landscape, two public green fields surrounded by railings were added around the original arbors in the yard, while the rest of it was equipped with rigid material. In terms of infrastructure, a washing room was added in the east side of the residency and a new outdoor public toilets was build in the west side. In 2014, a relevant department set up railing around the main monastery to forbid unrelated persons from approaching in order to avoid accidents. The original wide public area was reduced by 43.7% due to the unreachable function of public green fields and the enclosed buffer space around the main monastery (fig 13). But the residents did not mind. It was widely believed that these measures made the original cluttered yard more organized.

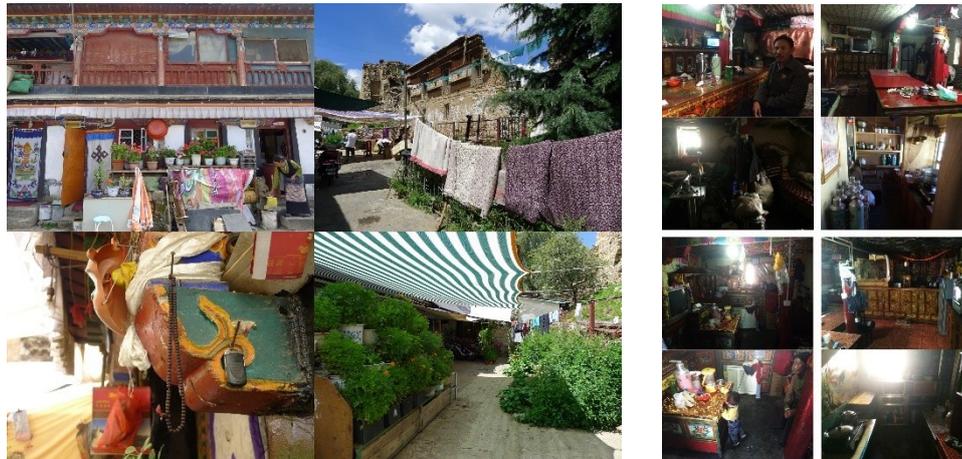
Fig 14. Residents's modifications on Sid-Lin, photoed by author, 2014.

Fig 15. Four examples of living condition of the residents, photoed by author, 2014.

The other over 30 permanent residents are the real owner of Sid-Lin Monastery. A small number of permanent residents, appointed as administrators, are responsible for the maintenance of the yard's hygiene and the coordination of neighbor conflicts. They also receive appropriate payment. Most of them have lived here over 10 years. A few of them even stayed for 40 years. Some inherited their parents' property and some moved in with their spouses. They have families in this yard and even some relatives. (fig 14)

Besides changing the scenes of life, residents of Sid-Lin Monastery also respectively transformed their private areas basing on their needs, especially within the limited area before their door. Some families showed affection for plants. They set up a pergola in front of their house to put various plot plants on; some put things that could not fit indoor, like washing machine and abandoned old furniture. Second floor residents between the vertical and horizontal aisles could not utilize public areas in the yard like first floor residents so they use simple board to close the second floor aisles. There are also families who extend their means of sustenance to the wider public area within yard. These reconstructions mentioned above may be too random some times and leave the yard in disorder but they have added strong smack of everyday life for Sid-Lin Monastery and become normal state of it. (fig 15)
