CONSERVATION OF RURAL EARTHEN ARCHITECTURAL HERITAGE: THE CASE OF MALATYA REGION

Tuba Nur OLGÜN, Müjgan BAHTİYAR KARATOSUN***

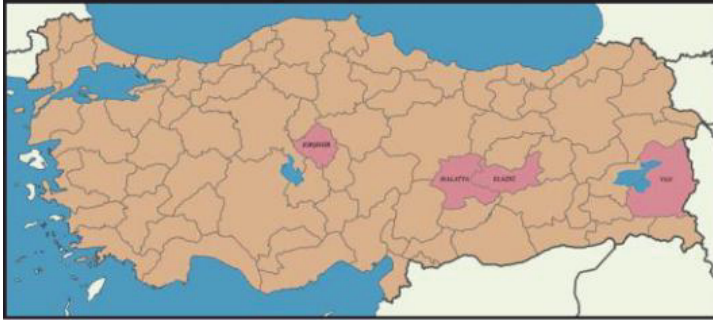
**Figure 1. The regions where earthen is most used in Anatolia
(Bahtiyar Karatosun and Olğun, 2018)**

rural areas; especially in some regions, soil stands out as the main building material and is used extensively in this sense. These regions can be listed as Kırşehir, Malatya, Elazığ and Van (Çelebi, 2012) (Figure 1).

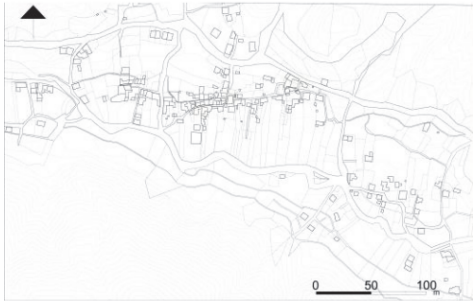
Figure 5. Site plan of Beybağı neighborhood

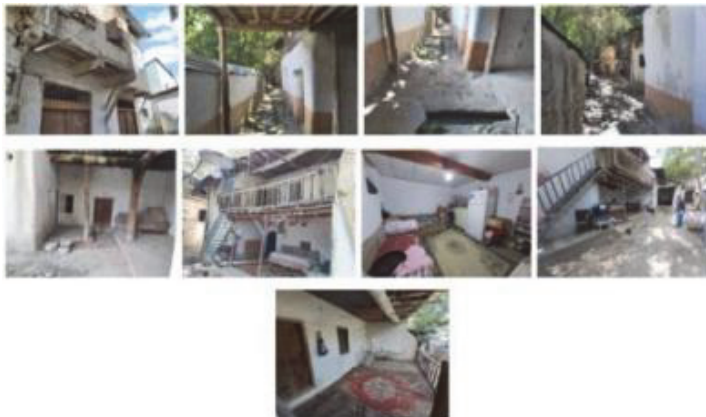
Figure 7. The number 10 house of Beybağı Neighborhood

The Beybağı neighborhood in Darende, one of the settlements in the Malatya region, which can be stated on the wall of the region, draws attention with its conserved earthen texture (Figures 3, 4, 5, 6). In this context, considering the general characteristics of the neighborhood, the population, which was 240 in 2013, dropped to 173 in 2017; Based on this, it can be stated that the settlement population is decreasing gradually. However, it can be stated that the main source of income in the settlement is livestock. While historical data about the settlement cannot be accessed; During the interviews with the villagers, it was stated that the village was founded in the late Ottoman period. When the data on the scale of planning and architecture regarding Beybağı was examined, it was observed that there was no study as a map, but all the buildings in the settlement were built with earthen materials and traditional construction technique. The residential buildings in the settlement are located in clusters consisting of two or more earthen houses gathering around a courtyard. Considering the space setup of these two-storey buildings; with the welcoming space entered from the courtyard and the living area integrated with this space; kitchen, bathroom and bedroom units can be accessed from the entrance to the living area. On the upper floors, which can be reached by a staircase outside, there are usually bedrooms lined up around a corridor. The courtyard is used extensively for most of the day, especially in the summer; however, it is also considered as a workshop where various productions are made. (Figures 7, 8).

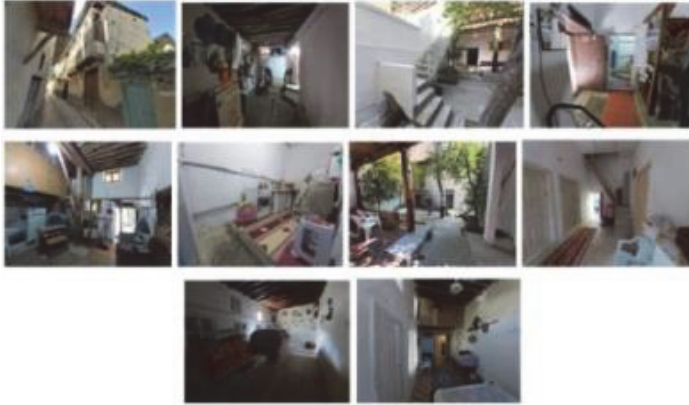
Figure 8. The number 14 house of Beybağı Neighborhood

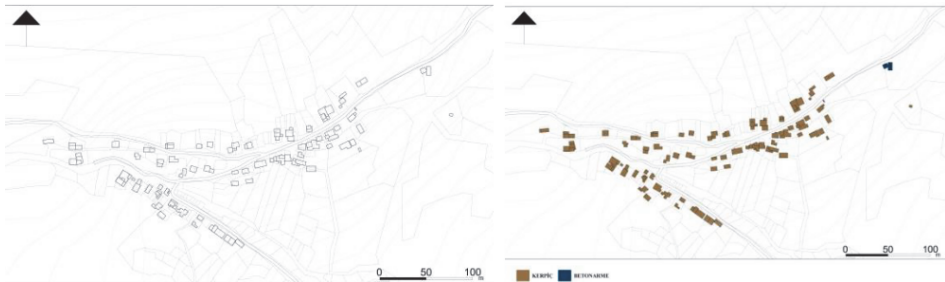
Figure 11. Site plan of Seyituşağı neighbourhood

When the data on the scale of planning and architecture regarding Seyituşağı is examined, it is seen that there is no study as a map, whereas all the buildings in the settlement are built with earthen materials and traditional construction technique; only the building in the cemetery was found to be reinforced. The residential buildings in the settlement are arranged as one or two floors. Considering the space setup of these structures; It is observed that the entrance to the building is provided directly from the street and there are rooms lined up around the corridor, which can be considered as a welcome place. In two-storey buildings, the same fiction is seen on the upper floor. (Figures 13, 14).

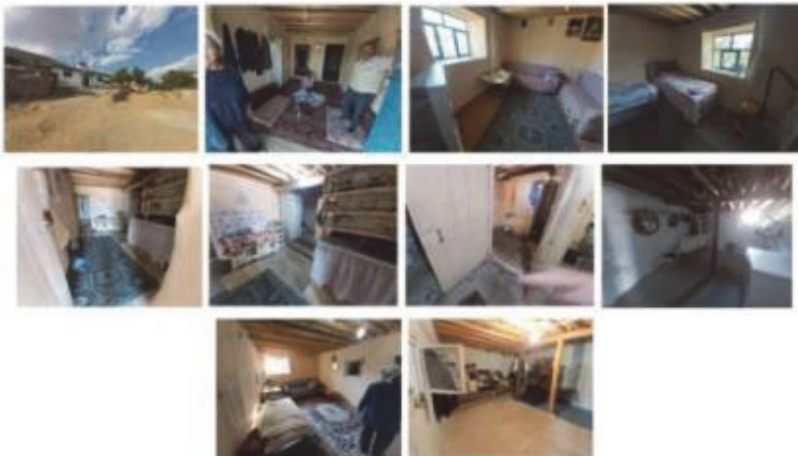
Figure 13. The number 10 house of Beybağı Neighborhood

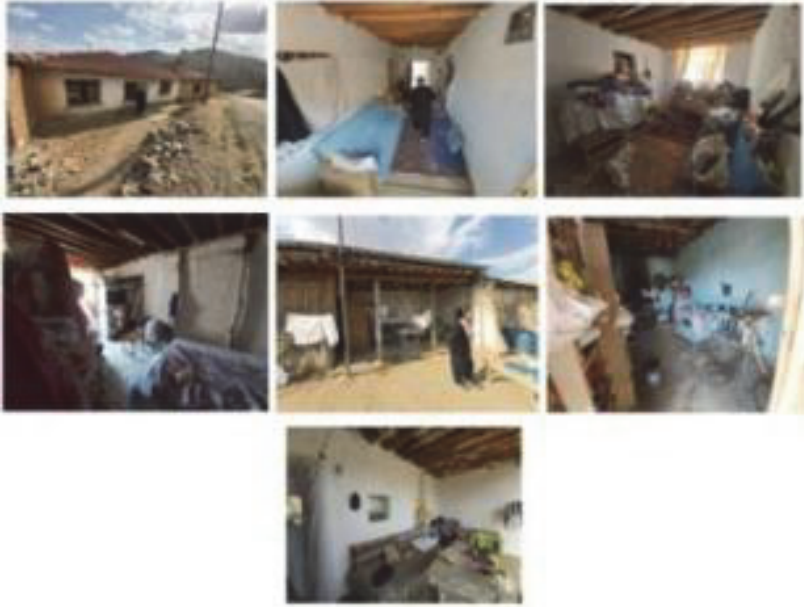
Figure 14. The number 14 house of Beybağı Neighborhood
